UNITED STATES ENVIRONMENTAL PROTECTION AGENCY
REGION IX – SOUTHERN CALIFORNIA FIELD OFFICE
600 WILSHIRE BLVD, Suite 1460
Los Angeles, CA 90017

**Region 9 Enforcement Division
75 Hawthorne Street
San Francisco, CA 94105
INSPECTION REPORT**

Inspection Date(s):	06/09/16		
Time:	Entry: 1:50 pm	Exit: 4:00 pm	
Media:	Water		
Regulatory Program(s)	CWA NPDES/Industrial Stormwater		
Company Name:	Allen Asset Management Group LLC		
Facility or Site Name:	Plastic Recycling Plant		
Facility/Site Physical Location:	14131 South Avalon Blvd.		
(city, state, zip code)	Los Angeles, CA 90061		
Geographic Coordinates:	33°54'11.00"N / 118°15'56.00"W		
Weather	Sunny, no clouds		
County:	Los Angeles		
Facility/Site Contact:	Mr. John Fang	Site Manager	
	Office #:	[REDACTED]	
Facility/Site QISP:	NA		
Facility/Site Identifier:	NA (UNPERMITTED)		
Media Number:	NA		
NAICS:	326199 – All Other Plastics Product Manufacturing (determined by Haskell based on observations during inspection of the Facility)		
SIC:	3089 – Plastics Products, Not Elsewhere Classified (determined by Haskell based on observations during inspection of Facility)		
Facility/Site Personnel Participating in Inspection:

Allen Asset Managem

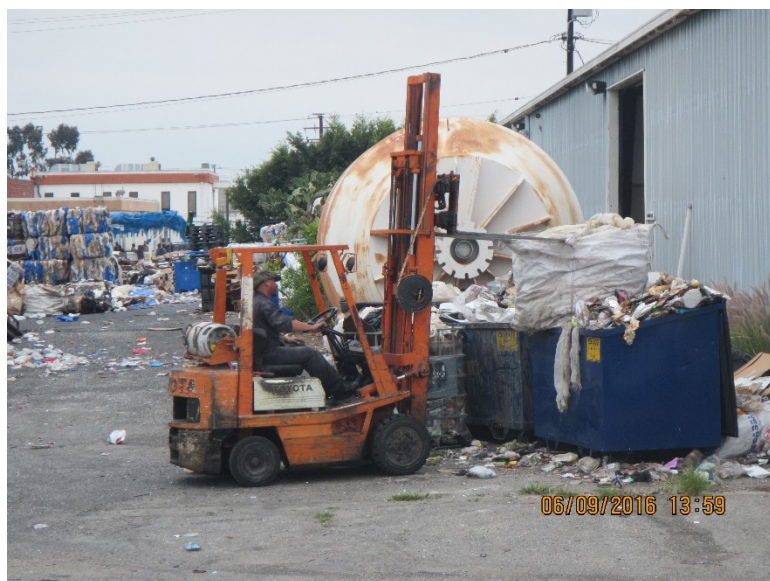
3. I observed numerous amounts of garbage in and around the dumpsters. Specifically, I observed a forklift operator setting a super sack of waste material on top of an already overtopping garbage dumpster. I also observed a large amount of plastic debris scattered on impervious pavement on the facility grounds. Mr. Fang stated that the facility typically cleans up twice a week.

IMG_0100.JPG. Forklift operator setting a super sack of waste material on top of an overtopping garbage dumpster.

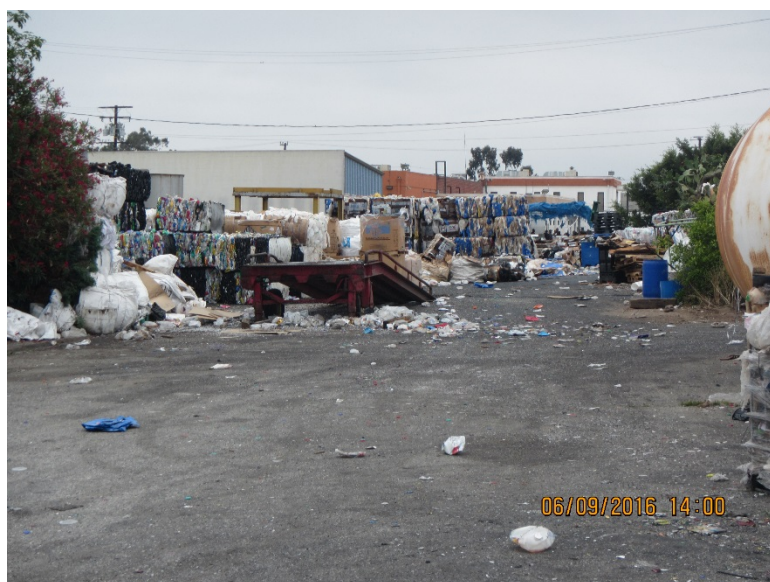
plastic fragments on impervious pavement throughout the facility, and around the portable loading dock. I observed that these items may have the potential to be mobilized from rain events via stormwater and flow into the city's MS4.

IMG_0103.JPG. Portable shipping/receiving stand-alone dock among scattered debris on impervious parking lot surface.

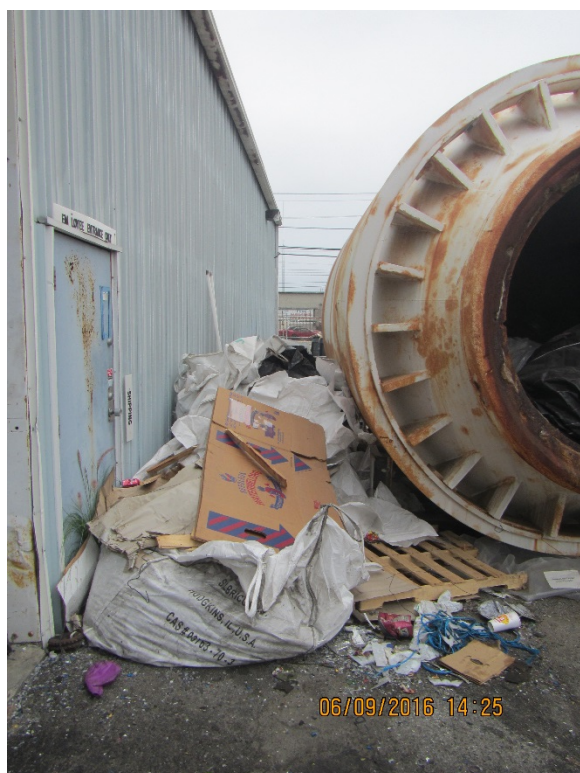
IMG_0108.JPG. Accumulated trash wedged between building wall and unused metal cylinder from Image 0098.

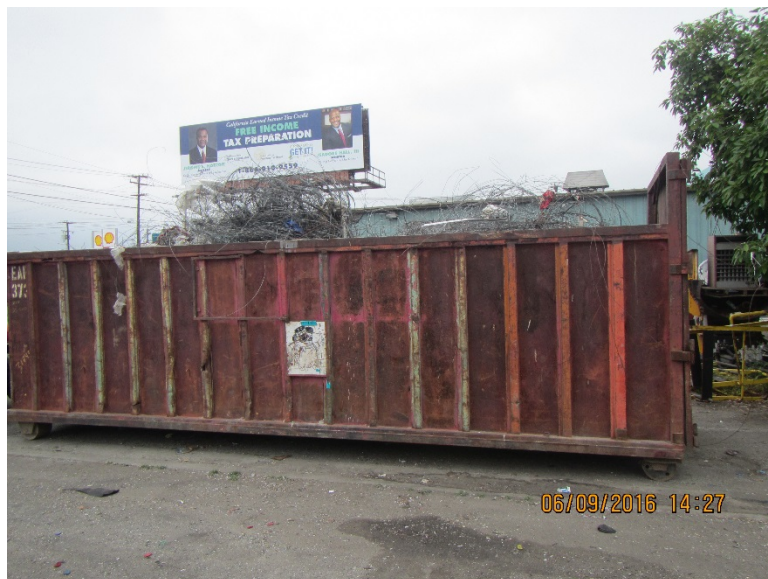
IMG_0109.JPG. Waste bin filled with scrap metal across the parking lot from the metal cylinder in Image 0098.

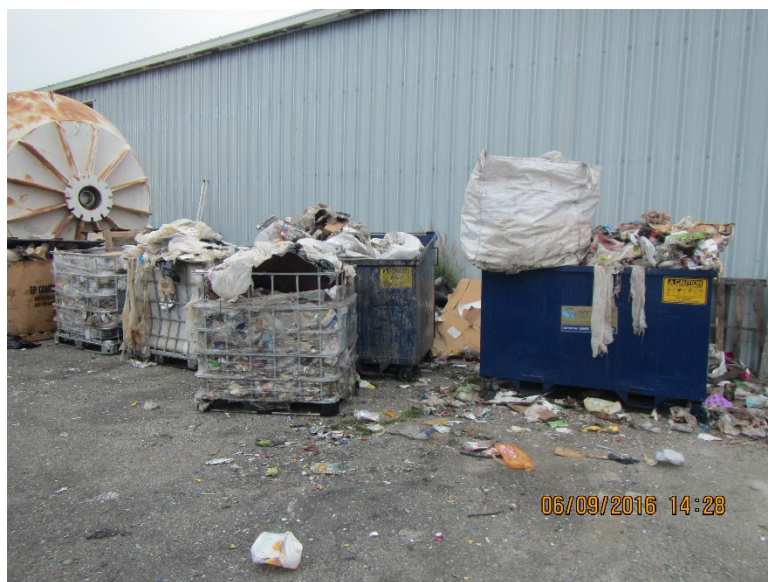
IMG_0111.JPG. Overtopping dumpsters, side view of Image 100.

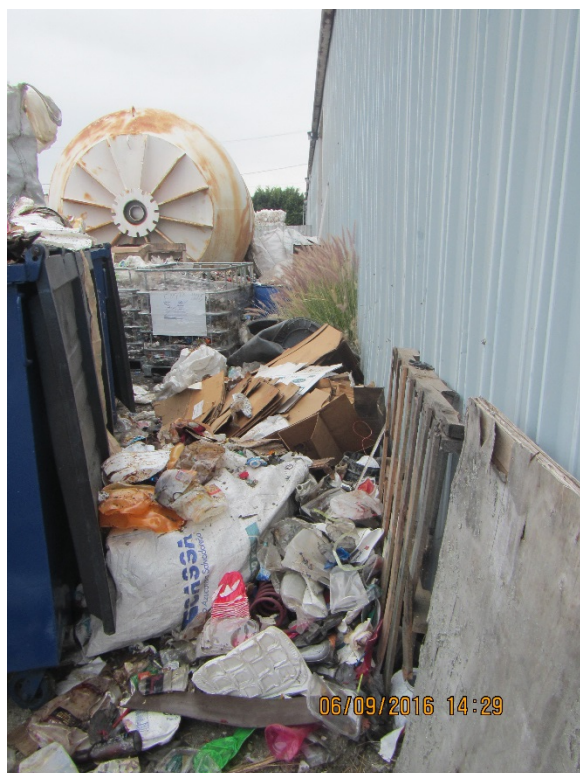
IMG_0112.JPG. Accumulated trash wedged between building wall and dumpsters from Image 0111.

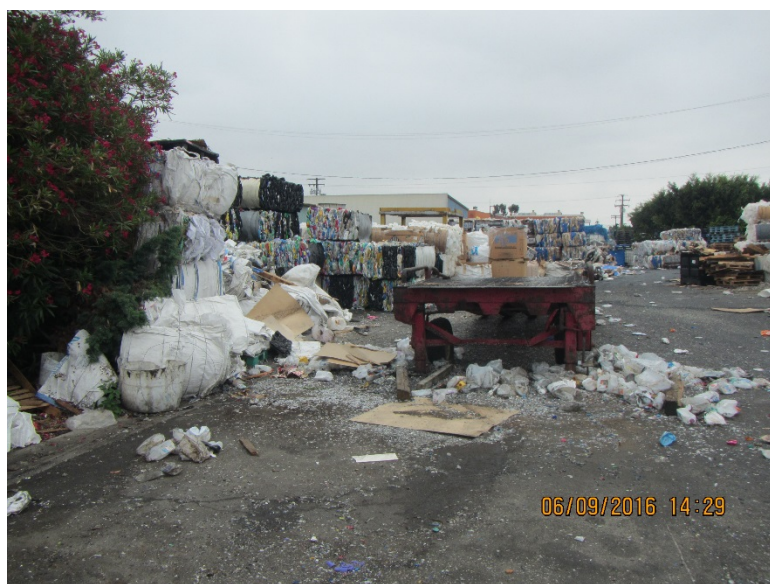
IMG_0114.JPG. Westward view of portable loading dock with plastic debris scatted throughout the area.

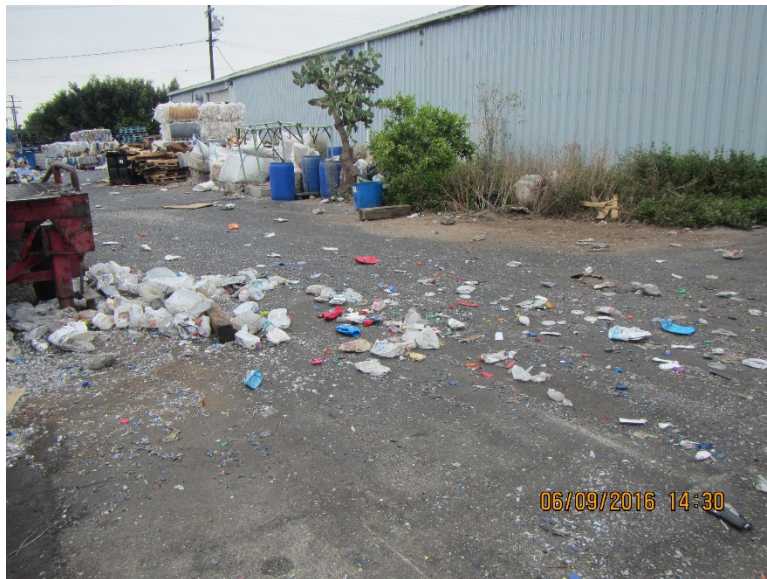
IMG_0115.JPG. Northwestward view of plastic debris scatted on impervious pavement adjacent to portable loading dock.

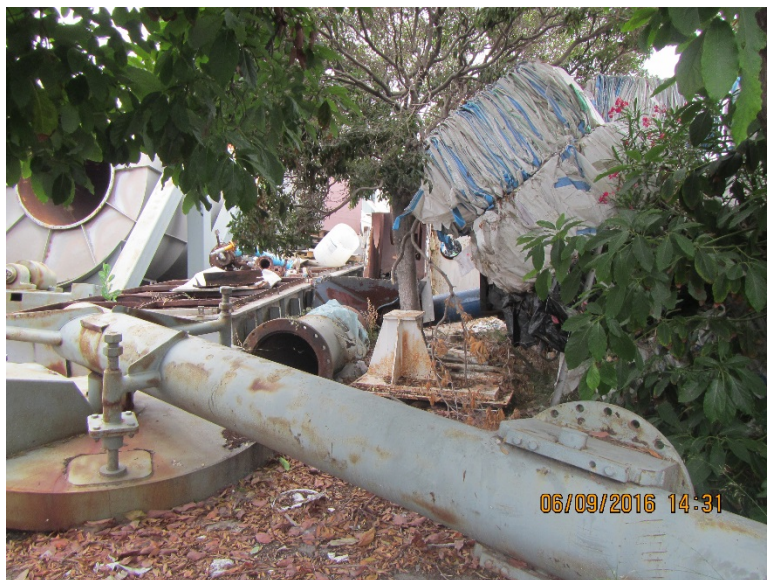
IMG_0117.JPG. Bales of stacked plastic materials topping over and resting up against a tree on southern facility parking lot.

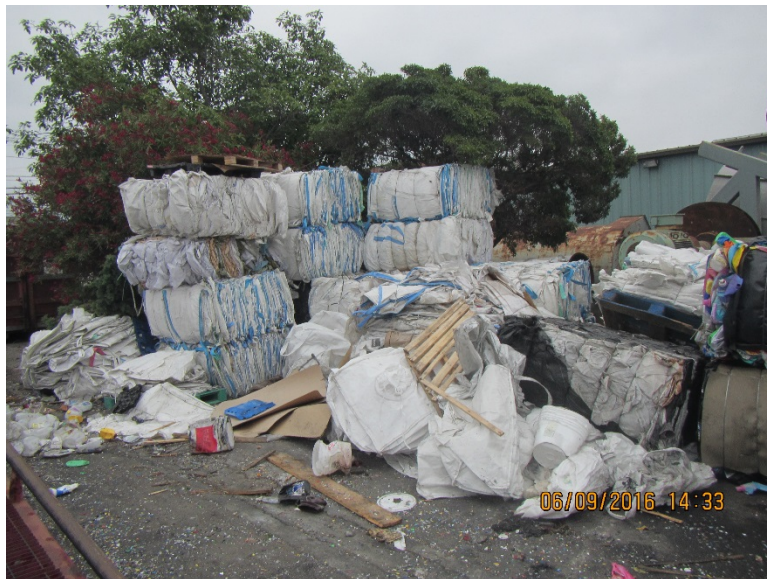
IMG_0120.JPG. Bales of stacked plastic materials tipping over and resting up against a tree from Image 0117.

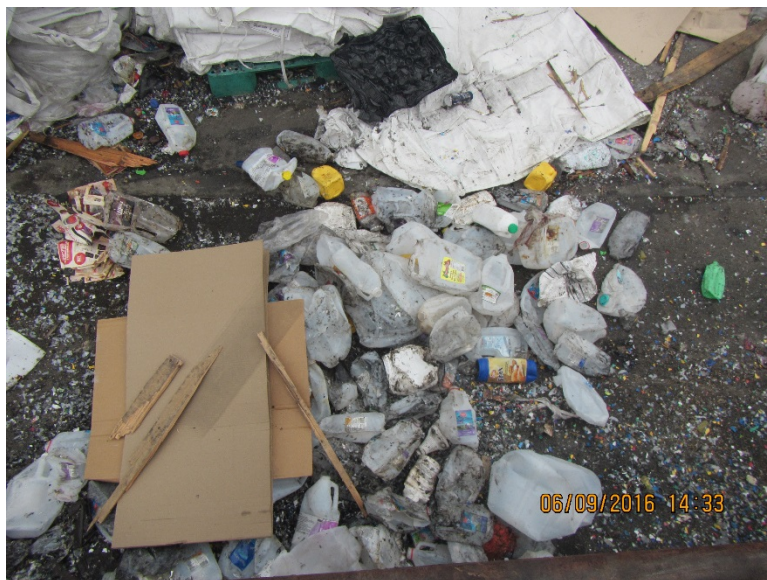
IMG_0121.JPG. Plastic bottles on impervious pavement adjacent to portable loading dock from Image 0120.

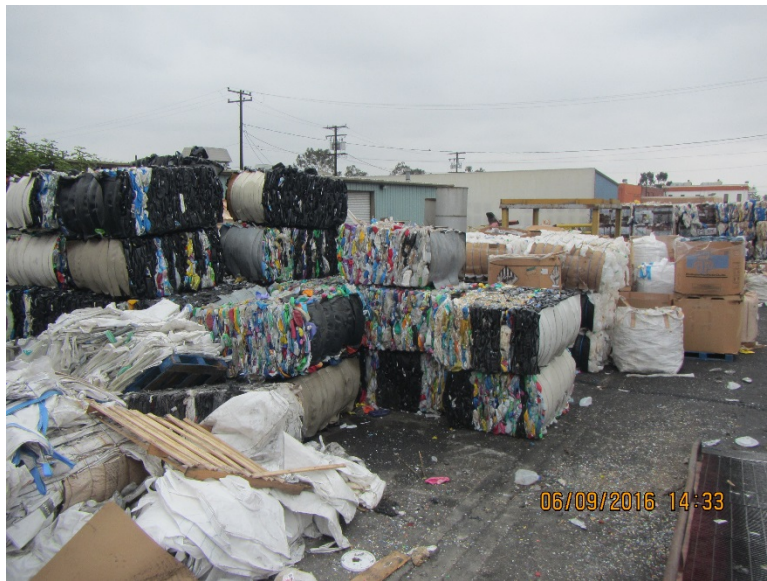
5. I observed the mismanagement of material storage to prevent discharge of pollutants in stormwater. For example, numerous bales of plastic material and folded super sacks were stacked outside throughout the facility. I also observed numerous amounts of plastic containers that were scattered throughout the facility on impervious pavement.

IMG_0122.JPG. Westward view of bales of stacked plastic materials on facility parking lot with scattered plastic fragments.

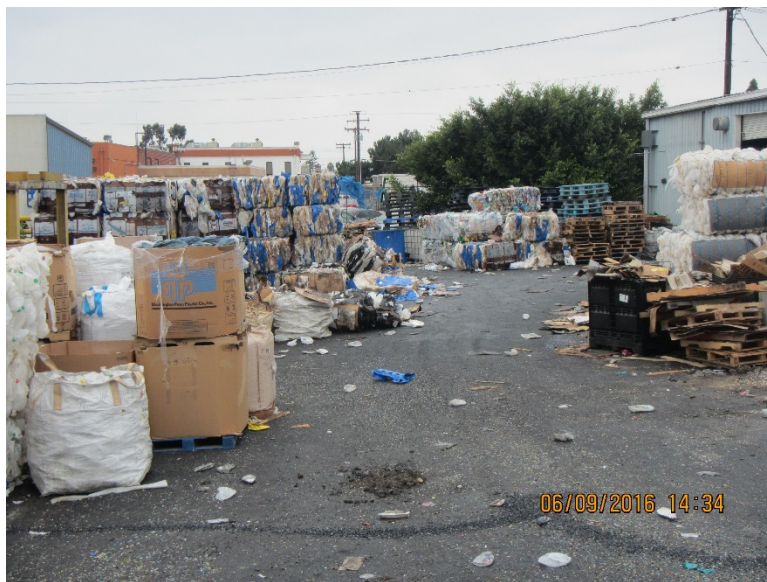
IMG_0123.JPG. Additional Westward view of bales of stacked plastic materials on facility parking lot with scattered plastic fragments.

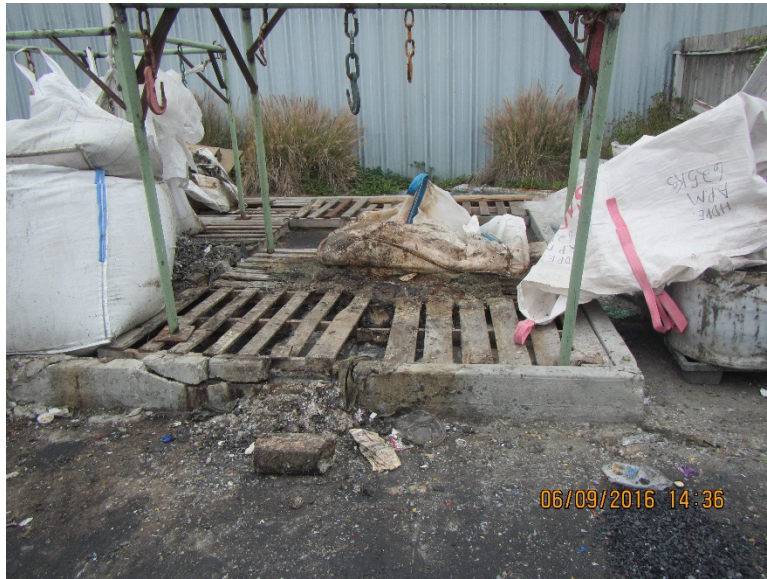
4. I observed a lack of proper material handling and waste management. Numerous outdoor super sacks leaking residues of oil and food waste residue product from the cleaning of plastic materials on the facility property. The super sacks were overtopping the damaged stormwater berm. Additionally, I observed open barrels of plastic fragments, food waste residue and oil adjacent to the super sacks.

IMG_0125.JPG. Super sack leaking sediment and grease on top of broken stormwater berm. Note oil stains around berm.

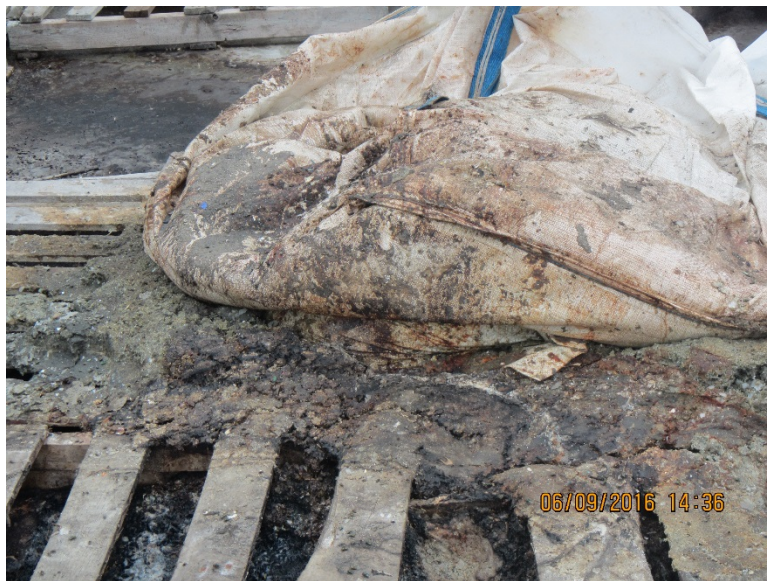
IMG_0127.JPG. Zoomed in image of super sack leaking sediment and grease on top of broken stormwater berm from Image 0125.

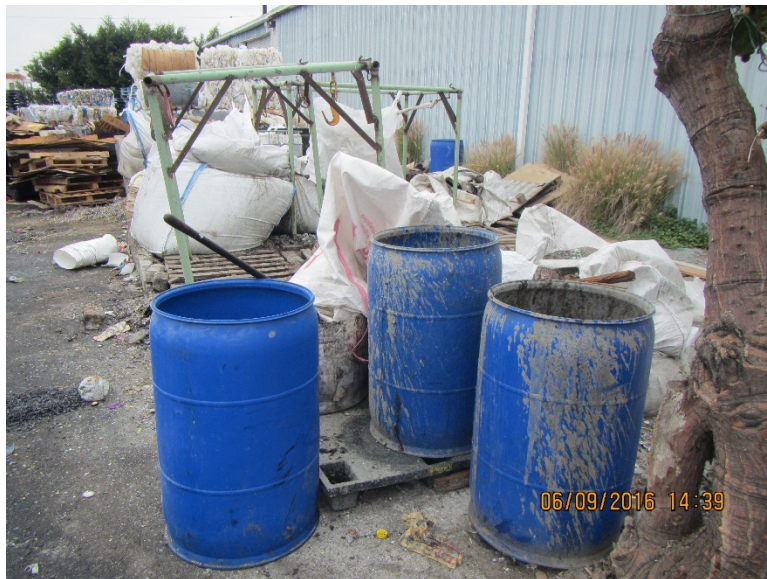
IMG_0128.JPG. Outdoor open containers adjacent to leaking super sack from Image 0125.

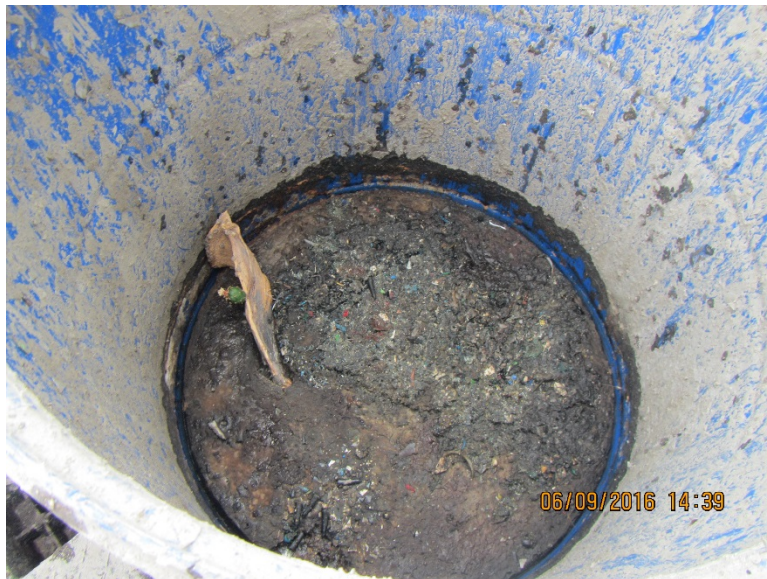
IMG_0130.JPG. Interior view of additional open container from Image 0128, filled with sediment and grease.

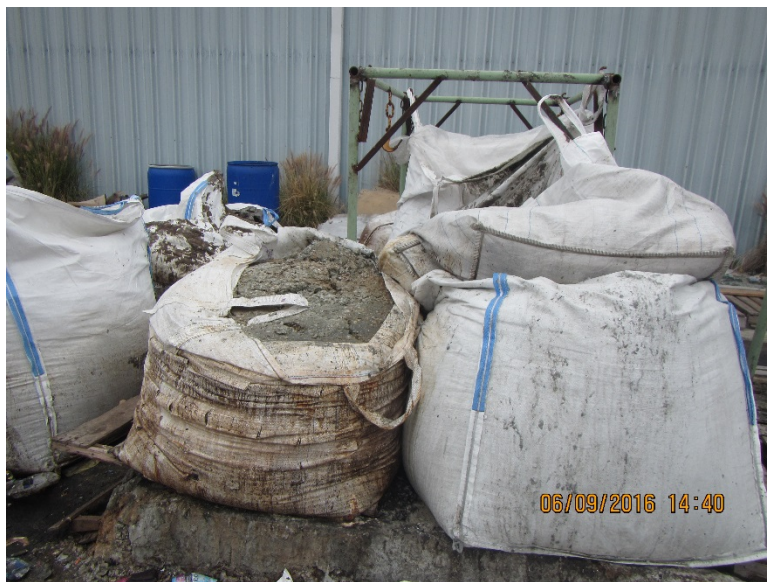
IMG_0132.JPG. Additional supersacks of residual sediment and grease without secondary containment.

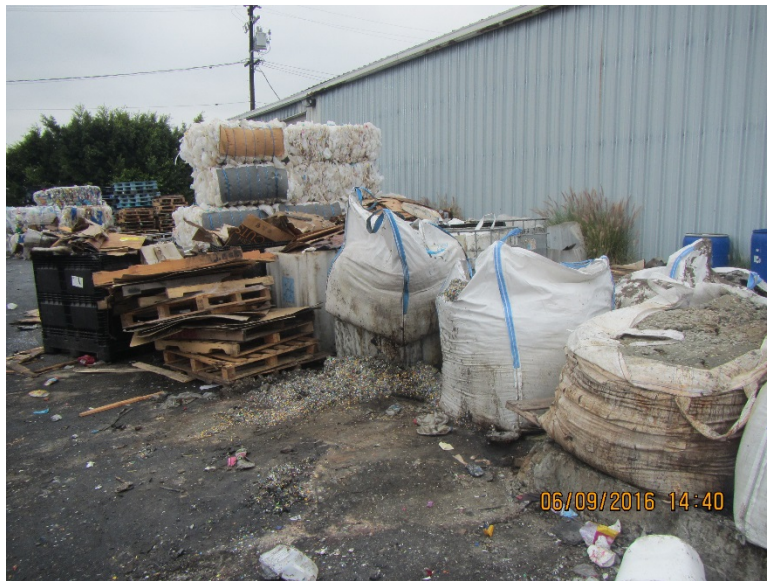
IMG_0133.JPG. Background image of additional supersacks of residual sediment and grease without secondary containment. Note spilled plastic fragments.

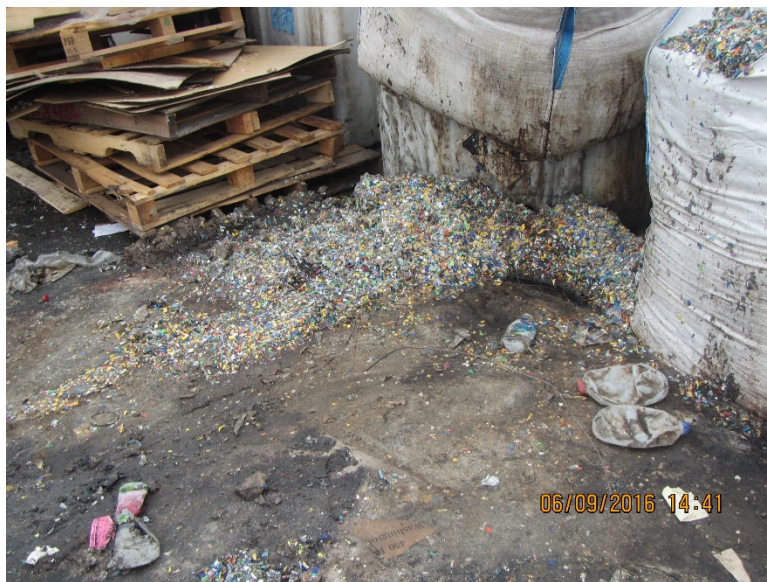
IMG_0134.JPG. Zoomed image of spilled plastic fragments from Image 0133.

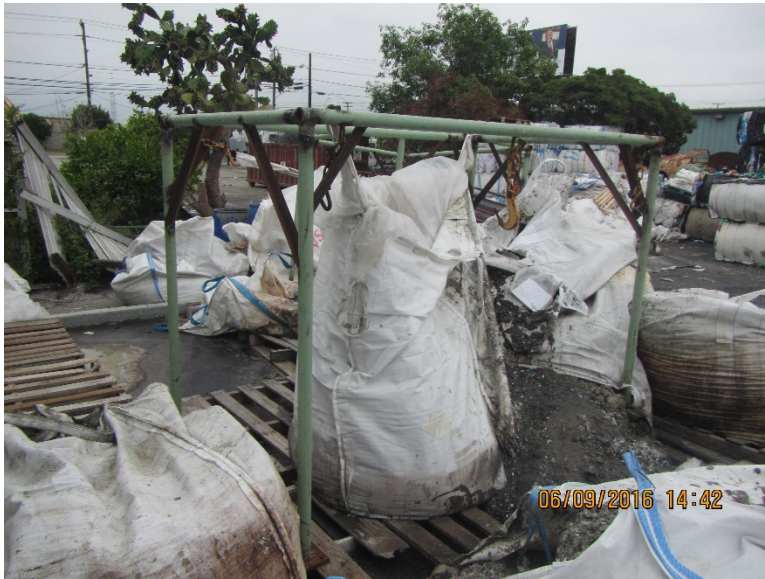
IMG_0136.JPG. Additional supersack leaking sediment and grease overloading stormwater berm.

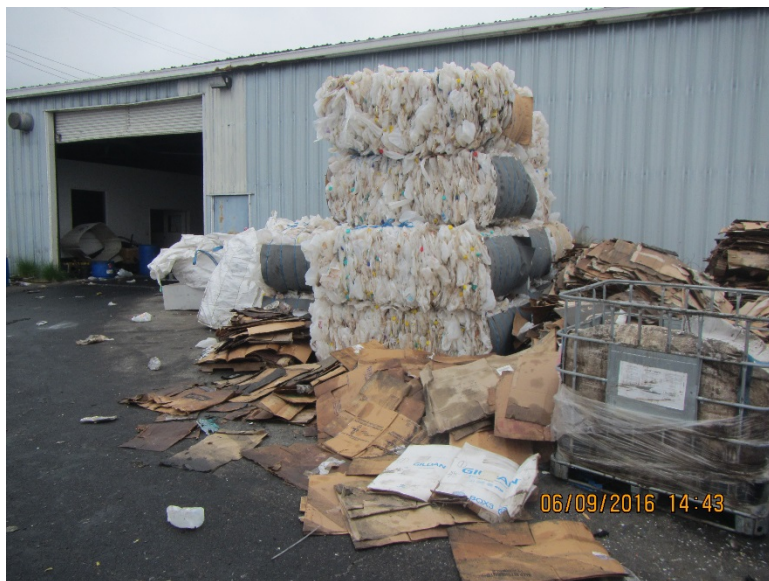
IMG_0140.JPG. Northward view of baled plastic materials from Image 0137 next to cardboard boxes and scattered plastic fragments on impervious pavement.

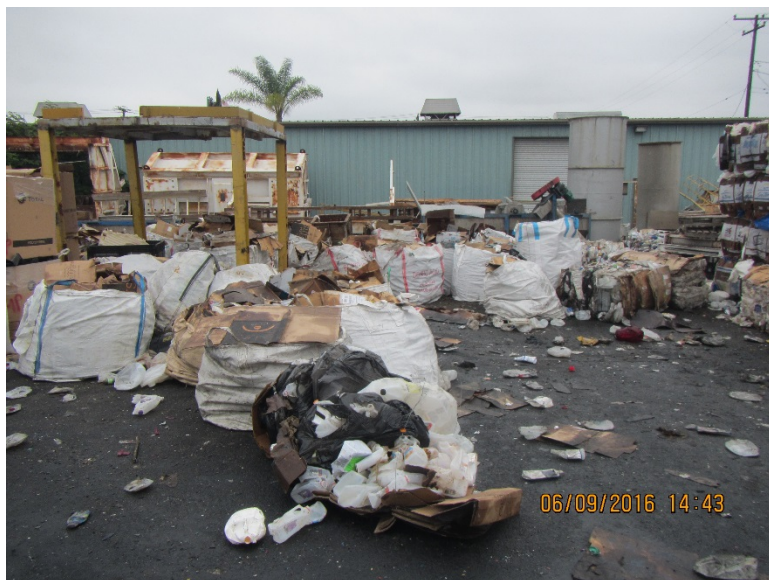
IMG_0141.JPG. Southward view of super sacks of plastic materials spilling on impervious pavement.

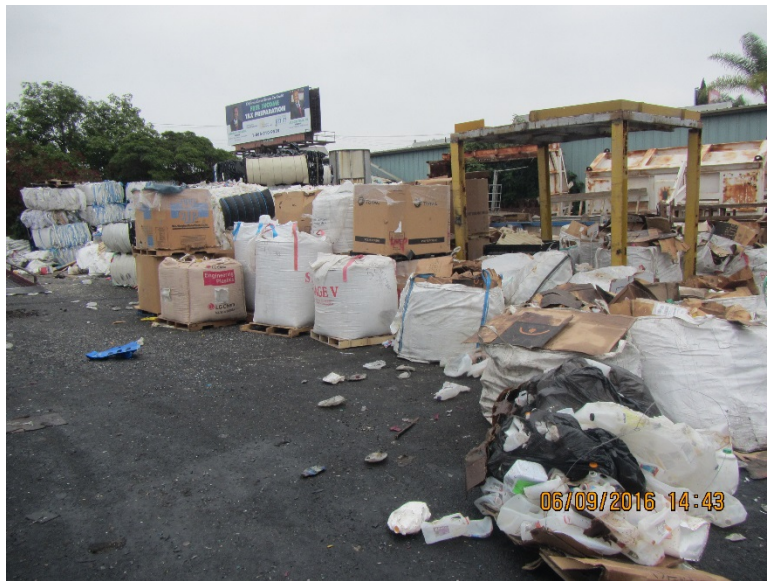
IMG_0142.JPG. Southeast view of super sacks of plastic materials spilling on impervious pavement.

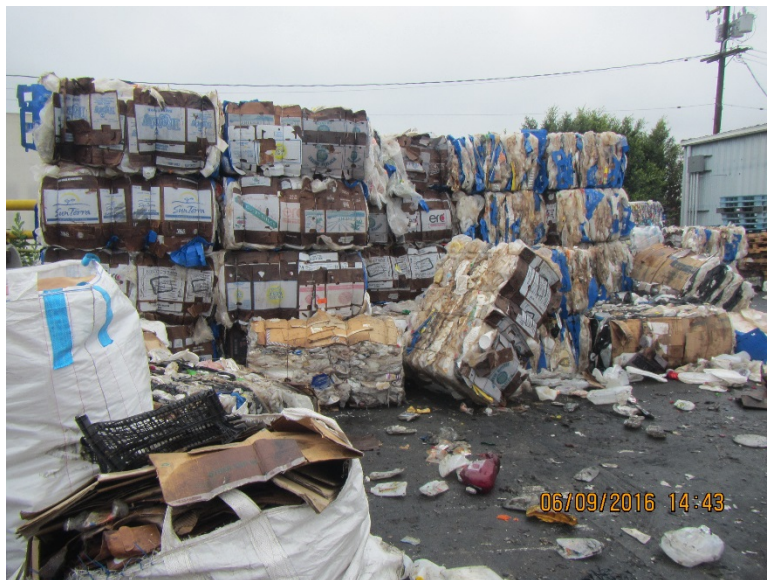
IMG_0143.JPG. Stacks of baled plastic materials with plastic debris scattered on impervious pavement.

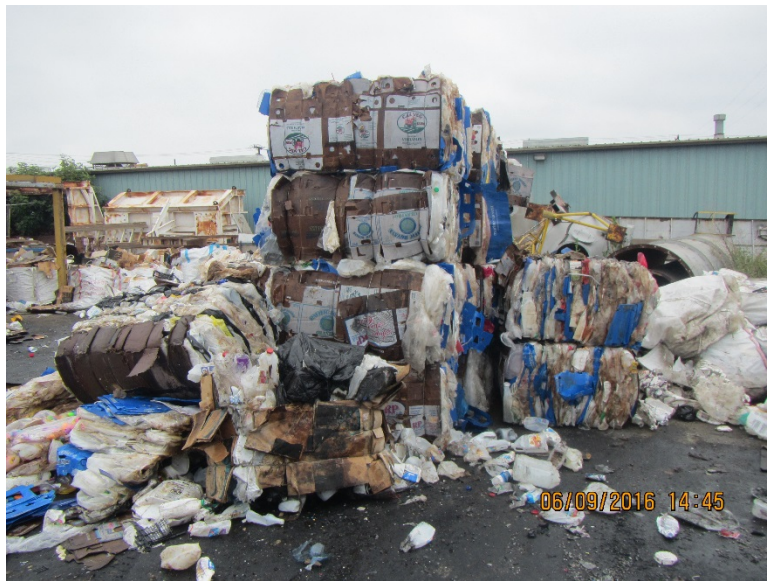
IMG_0144.JPG. Additional photo of stacks of baled plastic materials spilling onto impervious pavement.

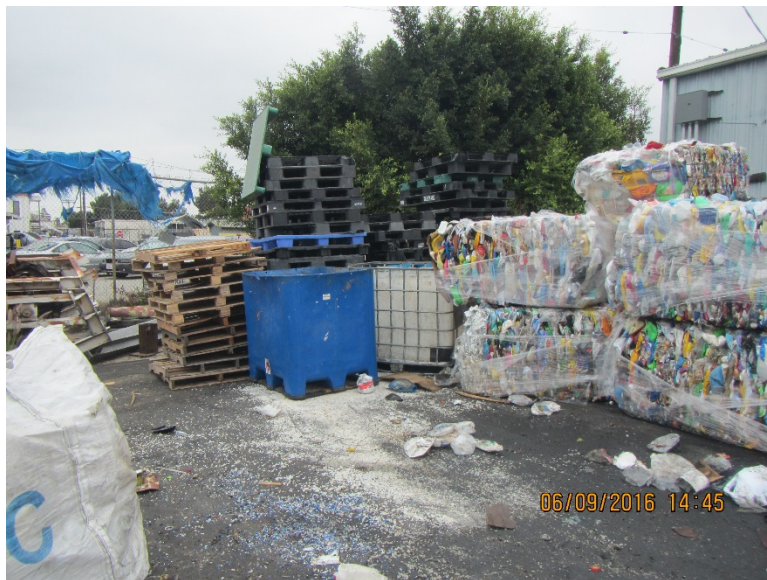
pavement around the super sacks (Attachment A, Images 0133 and 0134). Further westward as I walked, I continued to observe multiple stacks of baled plastic bottles and materials (Attachment A, Images 0137, 0140, 0141, 0142, 0143, 0144). Specifically, in Attachment A, Image 0145 there was a high degree of fragmented plastic materials on impervious pavement.

IMG_0145.JPG. Plastic fragments scattered on impervious pavement, with bales plastic materials in background.

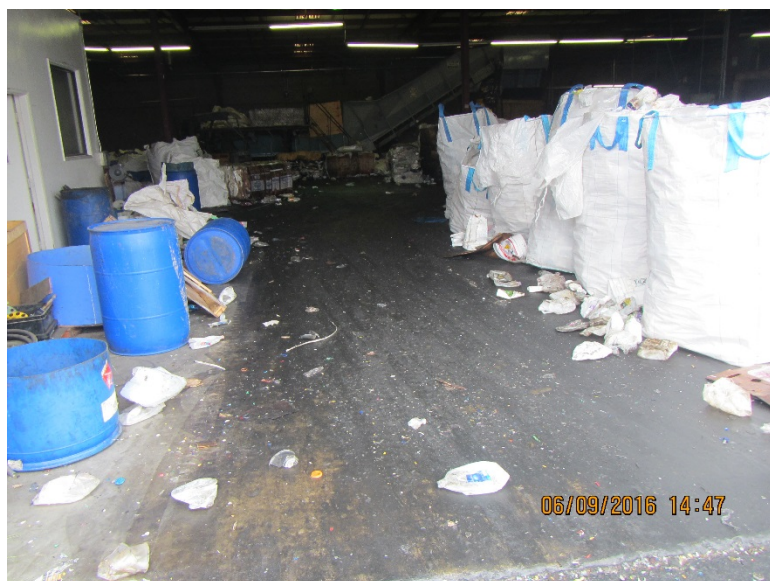
IMG_0147.JPG. Western entrance/exit to facility building. Note tracking of plastic materials and fragments.

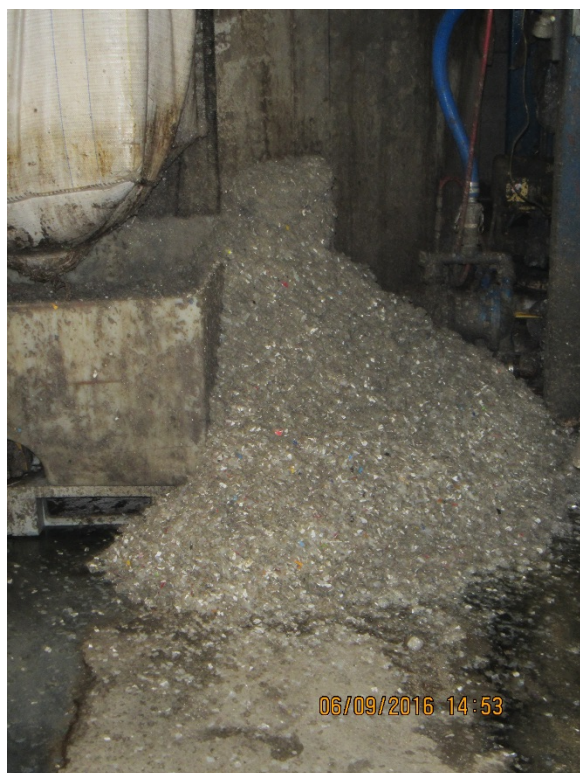
IMG_0156.JPG. Zoomed in plastic fragments spilling over from Image 0155.

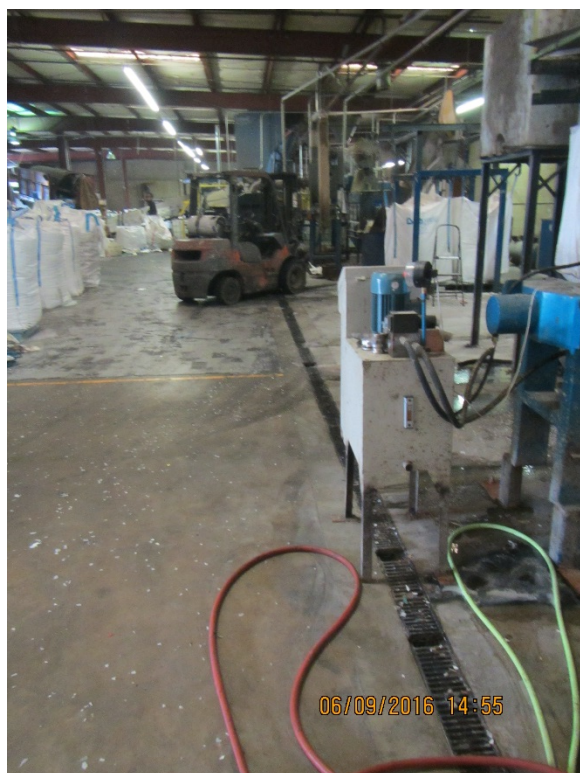
IMG_0158.JPG. Westward view of water collection trench running east-west inside facility building. Note plastic fragments on top of metal grate.

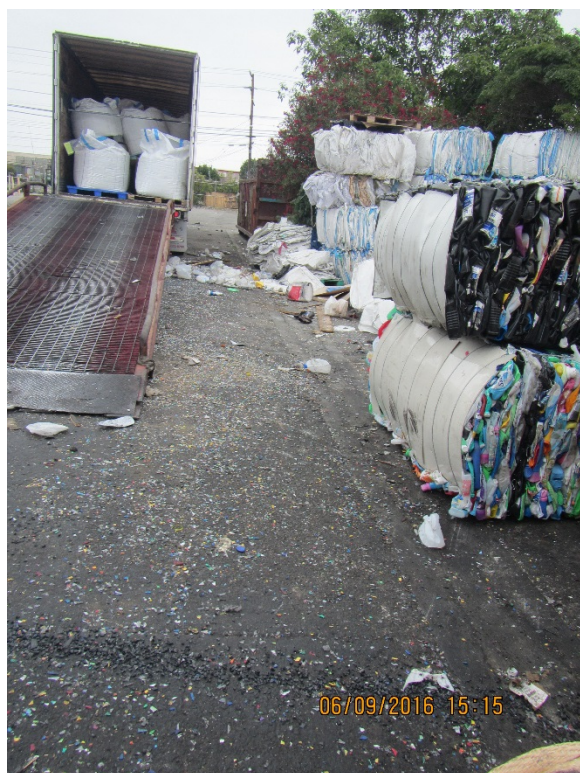
IMG_0169.JPG. Eastward view of westward gradient stormwater trench shown in image 0167. Note plastic fragments throughout trench.

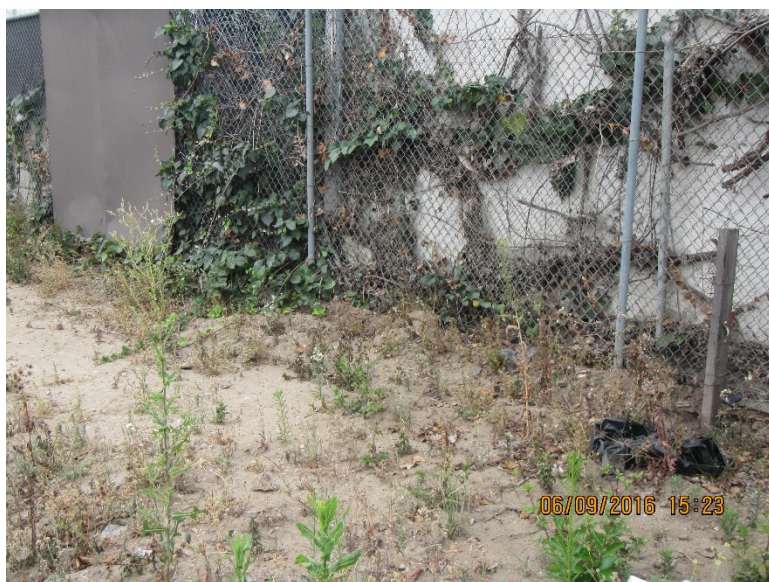
IMG_0182.JPG. Continuation of alternative flow path B from 0181. Note accumulated sediment along vacant boundary.

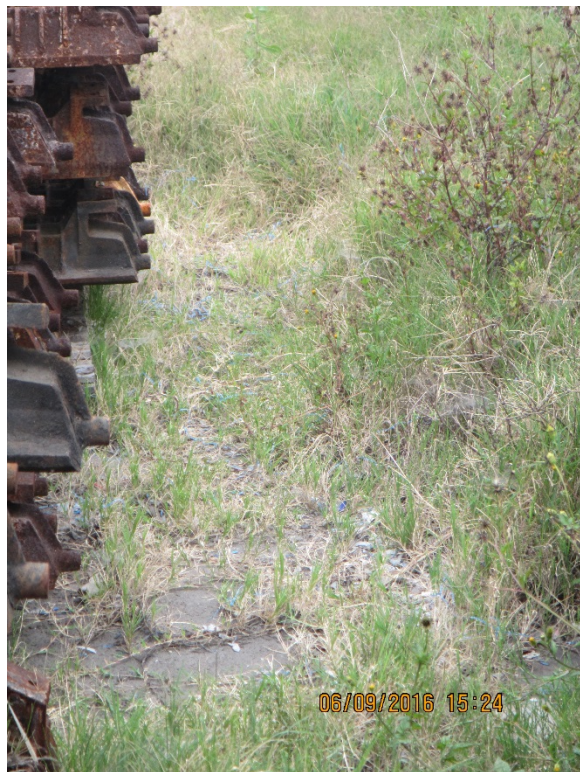
IMG_0186.JPG. Zoomed in image of 0185. Note plastic debris along flow path.

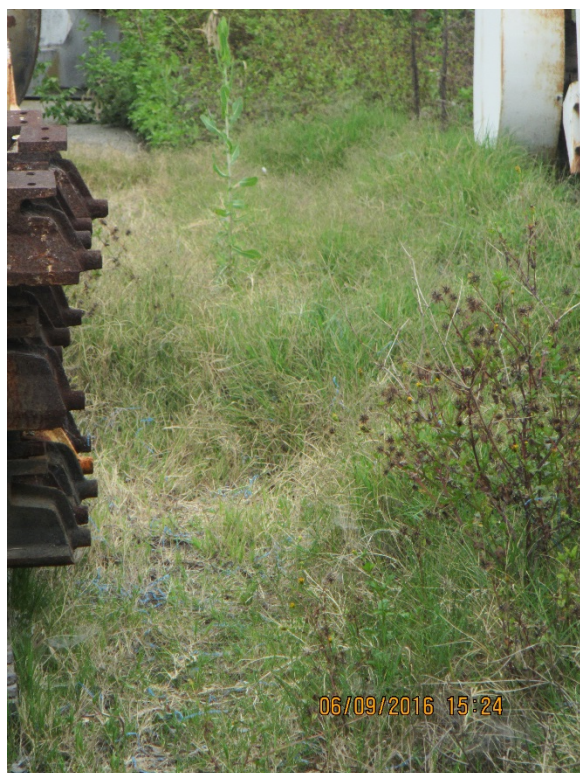
IMG_0187.JPG. Continuation southward of Image 0186.JPG. Note plastic debris along flow path.

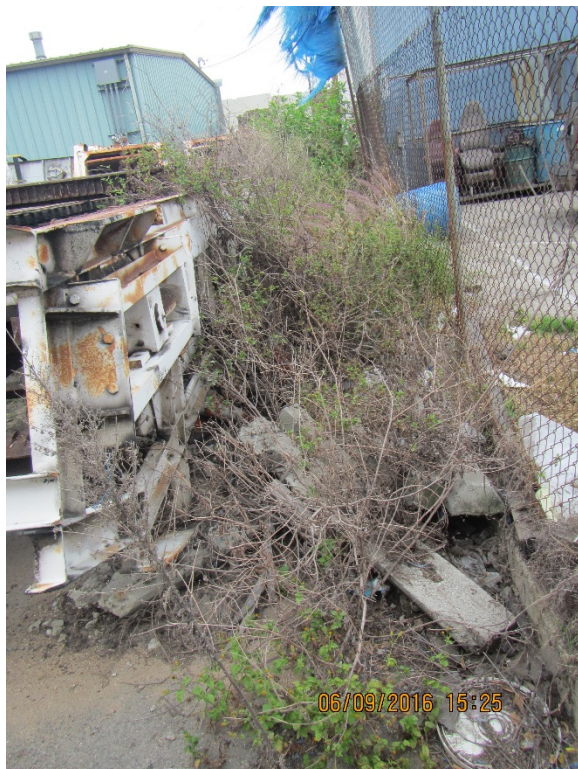
IMG_0189.JPG. Southward view facility boundary along adjacent property. Possible likelihood of run-on from neighborhood facility contributing to flow path in Image 0174.

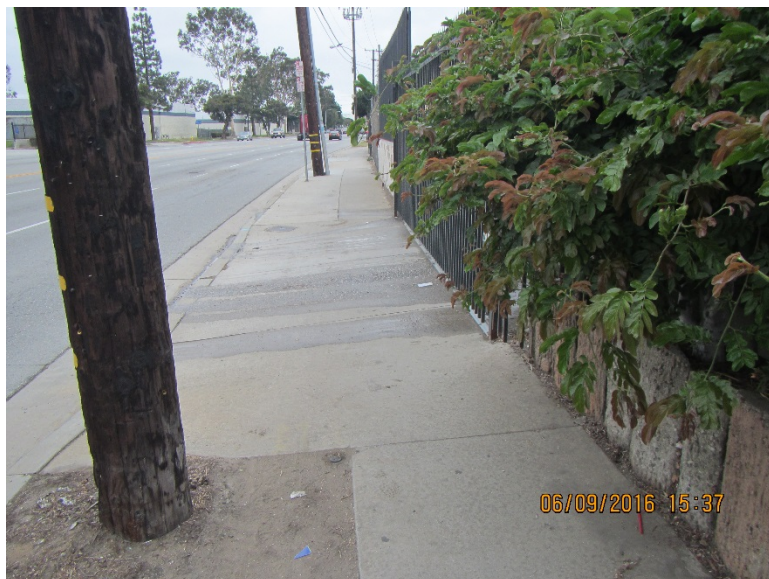
IMG_0194.JPG. Street view of alternative flow path B, potential discharge location corner from Image 0183. Note discharge from neighborhood facility.
